Assessing the Influence of Third Body Damage to Articulating Surfaces with Bone Void Fillers

Sean Aiken
Clinical Research Director

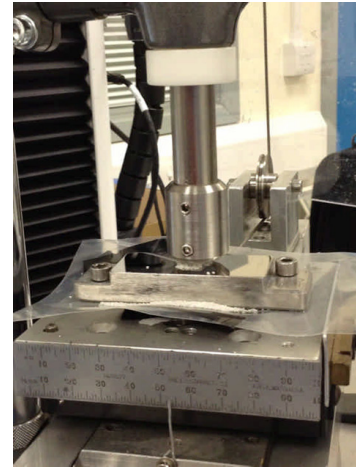
Figure 1

Figures 1 and 2. Phase one test rig. To simulate damage to CoCr plate by third body. Figure 3. Demonstrates the position of damage created on the plates during the test.

In phase one, the damage to CoCr plates by S T I M U L A N and PMMA bone cement was simulated using a six station pin on disk multi-axial reciprocating rig (figure 1). Third body particles were trapped between an UHMWPE pin and a polished CoCr rectangular plate. A load of 120N was applied to the pin and the plate was pulled for 5 adjacent strokes of a length of 15mm, at a speed of 8mm/min to simulate third body damage. A positive control (scratched with diamond stylus) and a negative control (no scratches) were also included. Changes in surface topography were analyzed using white light interferometry.

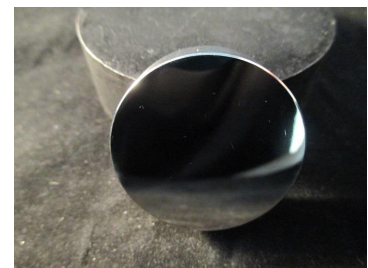
Figure 4

Figures 4, 5 and 6. Phase Two test rig. To determine damage to disk due to motion of pin on disk in the presence of particles of third body material.

In phase two, damage by STIMULAN and a competitor calcium sulfate material was assessed by a pin on disk frame rig (figures 4 to 6). The STIMULAN and competitor calcium sulfate materials were crushed and 1.5g of material was added to each of the stations, each containing 150ml of bovine serum. No crushed material was added to stations containing the control disks. A load of 200N was applied to each pin, which were moved in a square pattern with 10mm sides at a linear speed of 40mm/s for up to 480,000 cycles (4 cycles of 120,000). Deionized water was added during the testing to maintain constant fluid volume. Serum temperature was maintained at 37°C. Disks were examined after intervals of 120,000 cycles to assess damage using contact profilometry and microscopy.

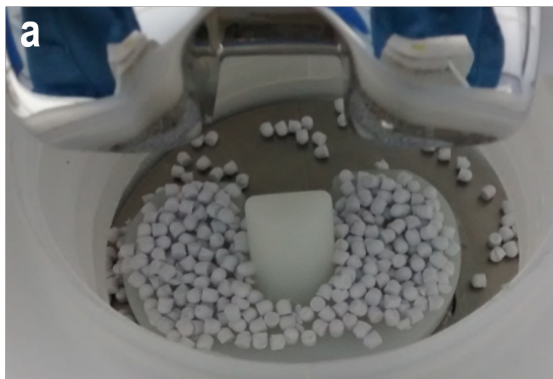
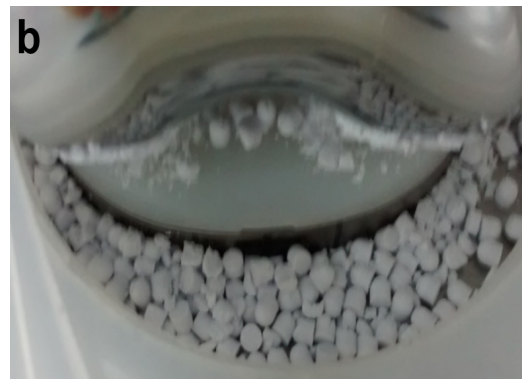
Figure 8a

Figure 8a. Beads of S T I M U L A N loaded on the tibial of the total knee replacement. Figure 8b. Damage simulation.

The total knee replacements were mounted in a motion simulator rig and 5cc of S T I M U L A N beads were placed between the articulating surfaces (figures 7, 8a and 8b). To assess the effect of the beads on CoCr surfaces, the simulator was run for 60 cycles without lubricant. Bovine serum was then added to the S T I M U L A N debris and run in the simulator for 115,000 cycles. This first test mimics "worst case" damage simulation for the maximum 6 week duration the S T I M U L A N would be present based on its dissolution rate. The second test mimics UHMWPE wear as a result of any damage resulting from the first test. To do so, the simulator is run with lubricant alone for 3 million cycles to determine wear over a simulated 3 years. After each test, the UHMWPE tibials were examined for measurement of wear and CoCr femorals assessed for damage using contact profilometry and microscopy, all in comparison to prostheses as negative (no S T I M U L A N added) and positive (CoCr pre scratched with diamond stylus) controls.

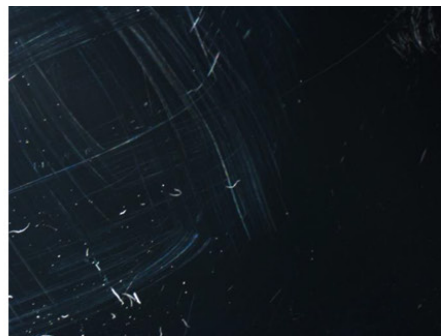
Figure 11. Microscope images, x6.5 magnification, 120,000 cycles.

The competitor calcium sulfate material caused more scratching to the CoCr disk than both the control group and the STIMULAN group at each time point. This is evident from the microscope images (figures 11 to 13) and was confirmed by the surface roughness measurements, with competitor calcium sulfate material resulting in higher surface roughness values compared to STIMULAN and the control (table 2).

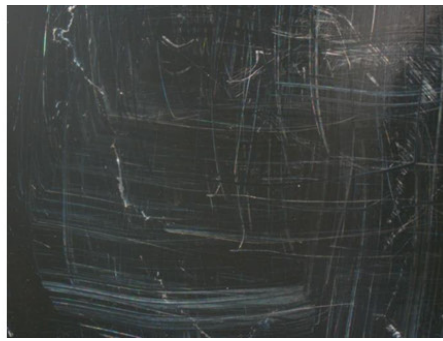
Figure 13. Microscope images, x6.5 magnification, 480,000 cycles.

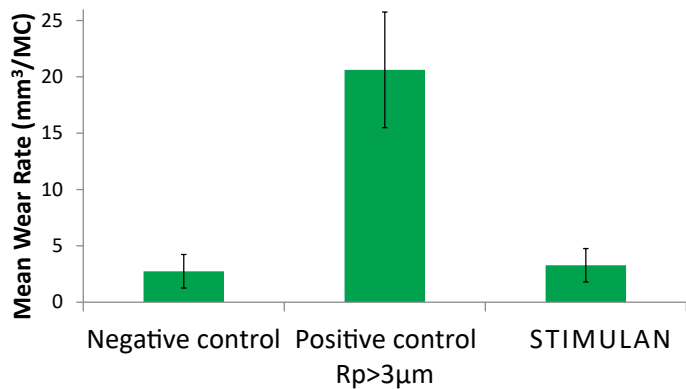
Figure 14. Mean wear rate/million cycles of UHMWPE tibials (n=6).

The wear simulation results in step 2, showed there was no significant difference in wear rate of UHMWPE tibials between negative controls and implants tested with STIMULAN between the articulating surfaces (figure 14). The wear rate of the tibial was significantly increased with positive controls.
