# STIMULAN<sup>®</sup>

POWER TO TRANSFORM<sup>™</sup>

# Case study

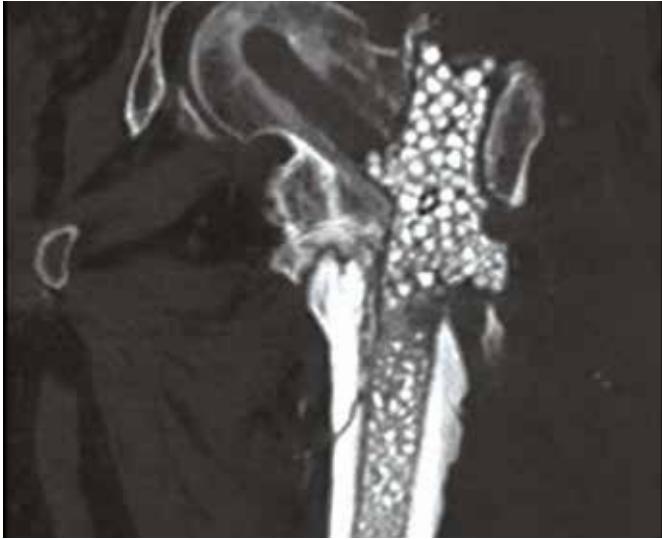
### Infected subtrochanteric fracture<sup>9</sup>

**Patient presented with:** infected femoral nail and non-union of left femur with persistent discharging wounds proximally and distally.

**Outcome:** at 7 months' follow-up there was complete healing of the non-union and at 1 year patient remains infection free, walking with no pain.

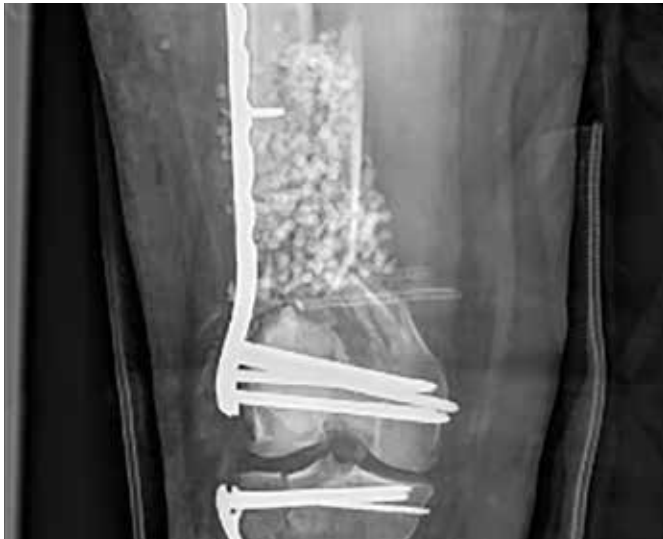
### Bilateral high energy femoral fractures<sup>11</sup>

**Patient presented with:** right open comminuted distal femoral fracture and tibial plateau fracture, and left closed comminuted femoral shaft fracture.

**Outcome:** complete absorption of **STIMULAN** and healing of the femoral defect after 4 months. At 1 year, patient was fully independently ambulatory with no pain.

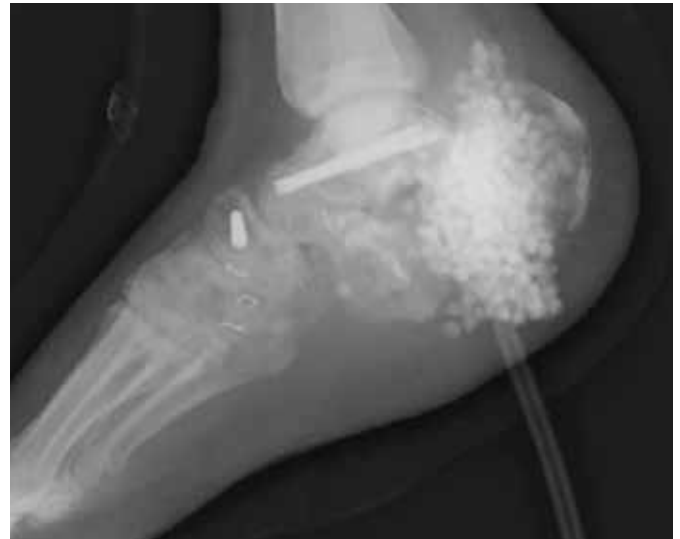
### Open calcaneus fracture infected with MRSA<sup>10</sup>

**Patient presented with:** infected, MRSA positive non-union and hardware failure 6 months after treatment for an open calcaneus fracture.

**Outcome:** at 13 months the absorption of **STIMULAN** was complete, the patient was weight-bearing and without sign of infection – amputation was avoided.

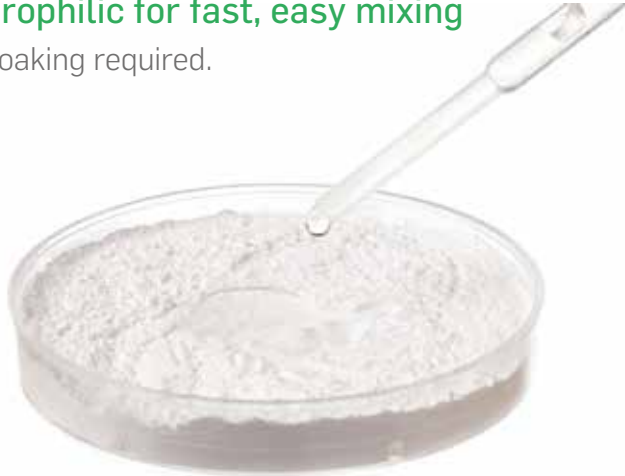
STIMULAN — mixes with liquid

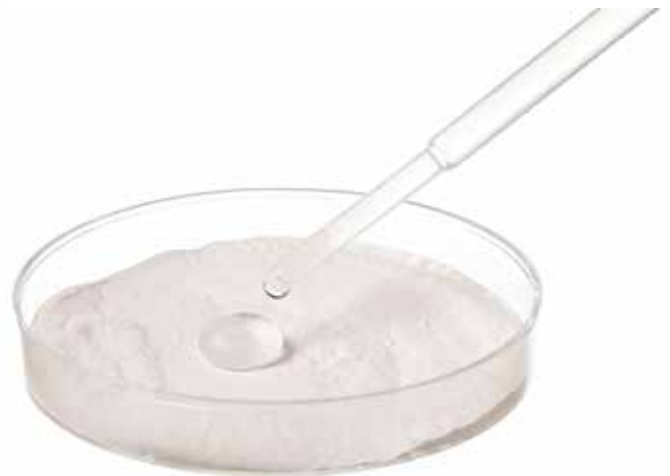
Competitor calcium sulfate — repels liquid

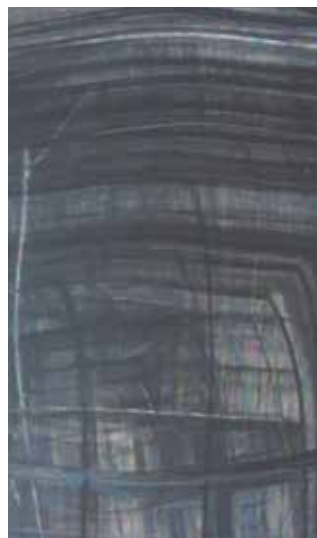
Microscope images (x6.5) of a cobalt chrome plate following damage simulation (360,000 cycles) with third body particles trapped between it and an articulating UHMWPE pin

STIMULAN does not damage total knee replacements when trapped between the articulating surfaces of the implant.

Less scratching than competitor calcium sulfate.<sup>21</sup>

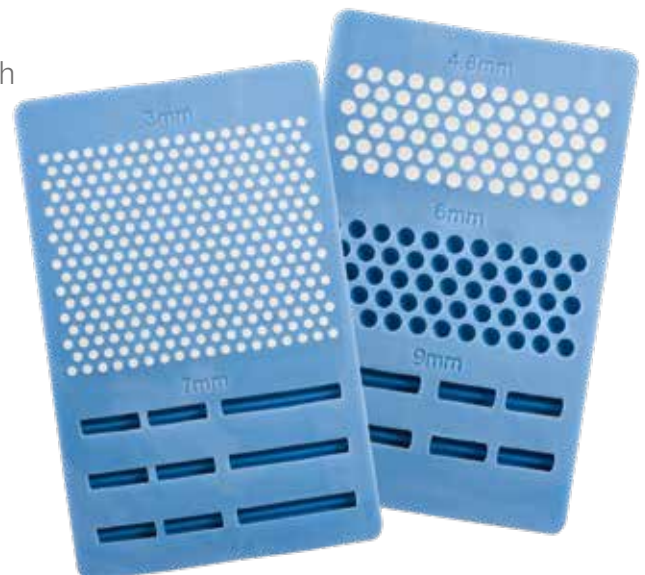
The combination bead and bullet mat is only available with the 3cc pack size

The mini 3cc pack size and combination bead and bullet mat were designed for smaller void volumes.

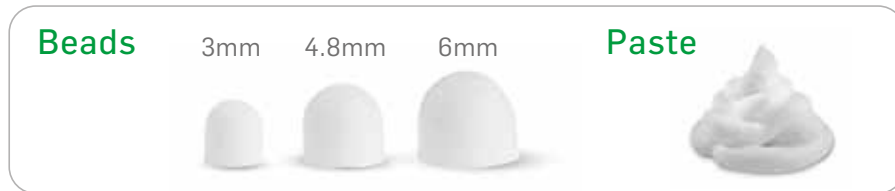
Bead mat available with **STIMULAN** Rapid Cure and **STIMULAN** Kit

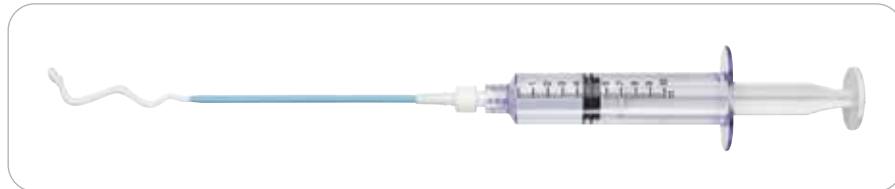
Syringe available with **STIMULAN** Kit

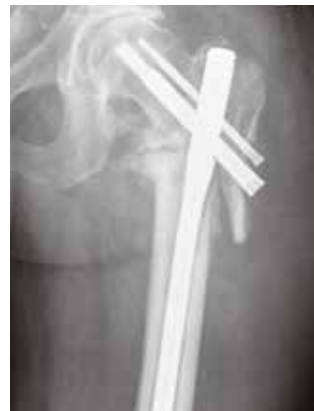
Pre-operative x-ray showing non-union

35-year-old male involved in a road traffic accident suffered multiple injuries and subtrochanteric fracture of left femur. This was nailed, but subsequently, he developed infection and drainage from both proximal and distal locking screw areas. He went to theatre multiple times and developed wound approx. 15cm on the proximal lateral thigh, which was treated with VAC.

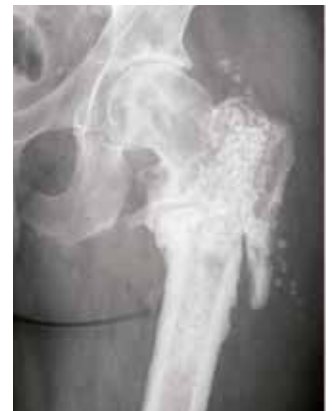
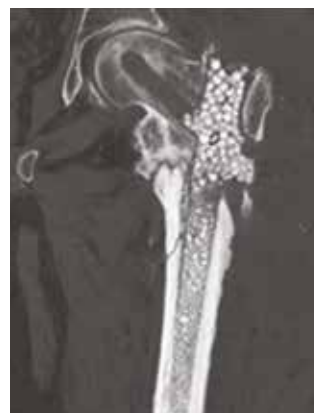
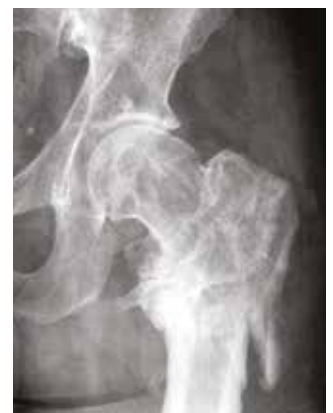
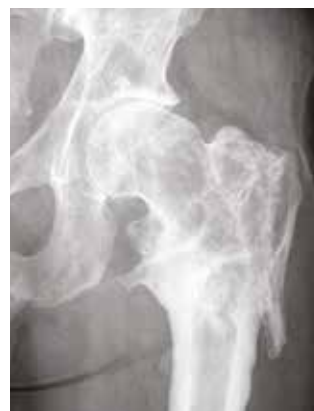
X-ray – 2 months

CT – 2 months

2.5 months

1 year

2.5 months' post-operative x-rays showed almost complete absorption of the **STIMULAN** beads and at 7 months there was complete healing of the non-union.

At 1 year follow-up, the patient remains infection free, walking with no pain.

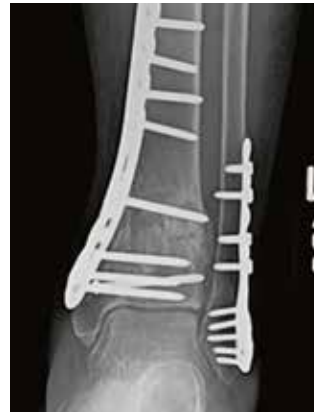
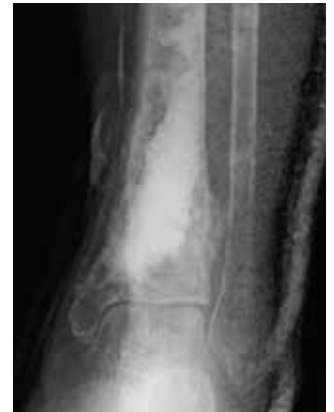
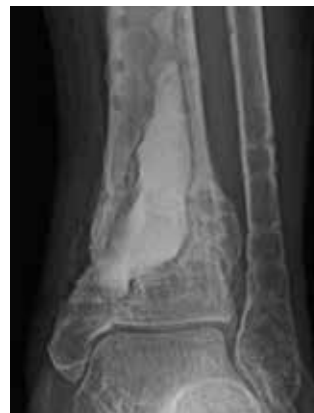
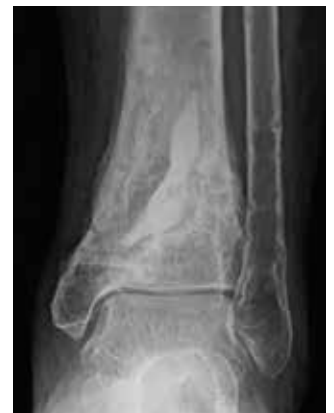
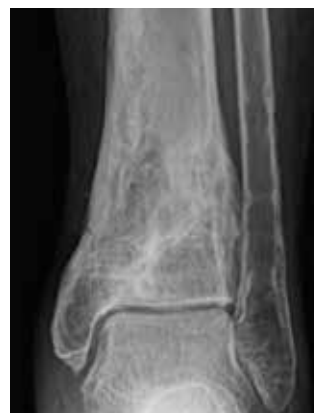
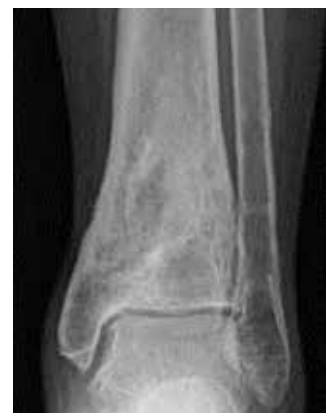
Presentation

Post-operative

1 month

11 weeks

6 months

15 months

Hardware removal and repeat debridement on the medial side of the ankle resulted in a large dead space which was managed using **STIMULAN** paste. Antibiotics were administered to treat the infection.

6 months after treatment the patient was free from infection, fully weight-bearing and without restrictions on activity – with complete absorption of **STIMULAN** paste.

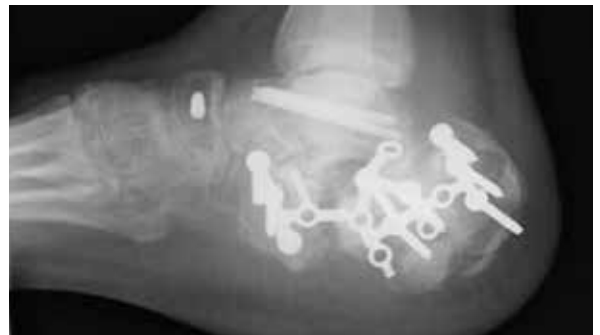
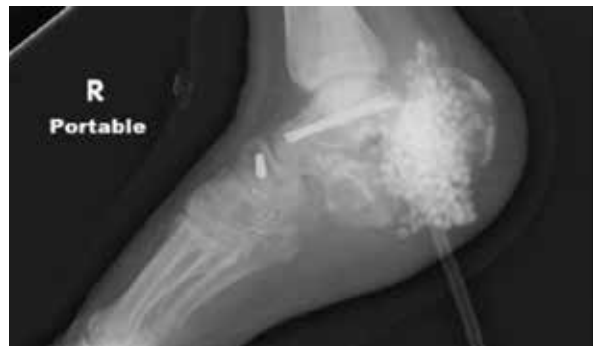
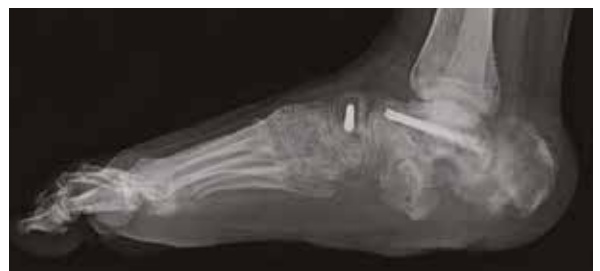
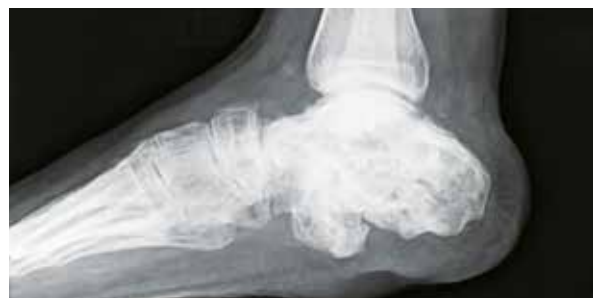
Presentation

Post-operative - Stage 1

Stage 1 complete

13 months after subtalar fusion,  
11 months after hardware removal

Hardware removal, debridement of grossly infected bone and soft tissues. **STIMULAN** was used to fill the resulting dead space. I.V. antibiotics were administered for 8 weeks.

Infection eradicated, soft tissues healed, infectious lab studies normal (1 month after I.V. antibiotics completed). Foot suitable for correction of proximal migration of calcaneus (soft tissue releases) and subtalar fusion.

This patient is now weight-bearing as tolerated and clinically no signs of infection. Infection in open calcaneus fractures is common and in some series amputation rates exceed 50%. For this patient a 2 stage approach was utilized to treat the infected non-union. Removal of hardware and aggressive debridement of the bone. The dead space was managed with **STIMULAN**.

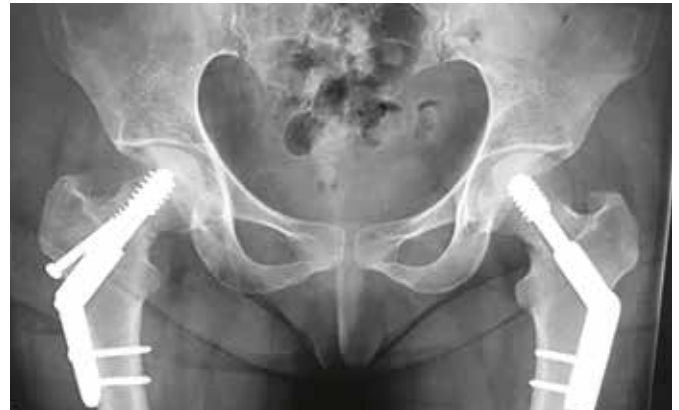
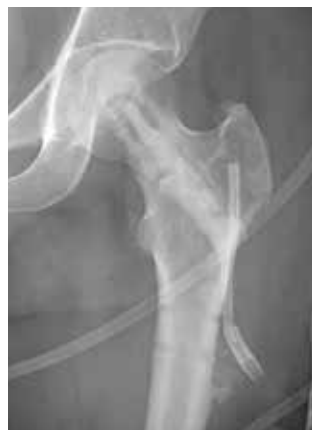
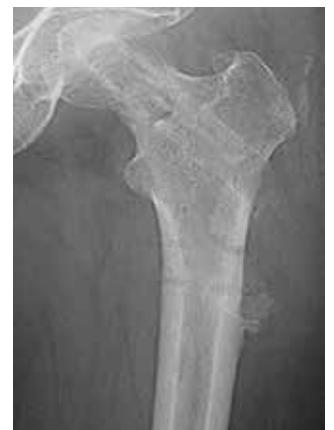
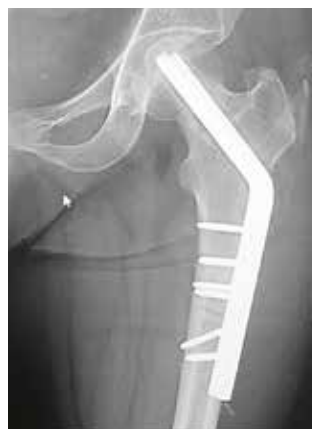
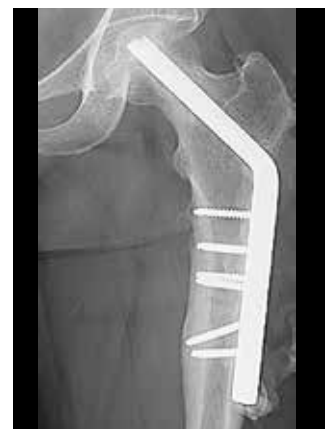
Initial post-operative

Stage 1 – post-operative

Stage 1 – 6 weeks post-operative

Stage 2 – 4 months

Stage 2 – 2 years

The sliding hip screw was removed from the left femur and multiple meticulous excisional debridements were performed. 20cc of **STIMULAN** paste was injected into the proximal femur bone void. Bacterial cultures revealed *Propionibacterium Acnes*. Antibiotic treatment was administered based on the sensitivities of the organism and I.V. antibiotics were administered for 6 weeks following surgery.

At 6 weeks, autologous bone graft and 10cc of **STIMULAN** paste were placed at the femoral neck non-union site. Internal fixation was performed with a blade plate device.

6 weeks after stage 1 treatment, the patient was free from infection with complete absorption of **STIMULAN** paste. 4 months after stage 2 treatment, the non-union site appeared to be healed with no hardware failure and complete absorption of **STIMULAN**. Imaging at 1 year after stage 2 treatment confirmed consolidation at the non-union site and stable hardware.
