STIMULAN[®]

Perfect partner for cases with an infected site

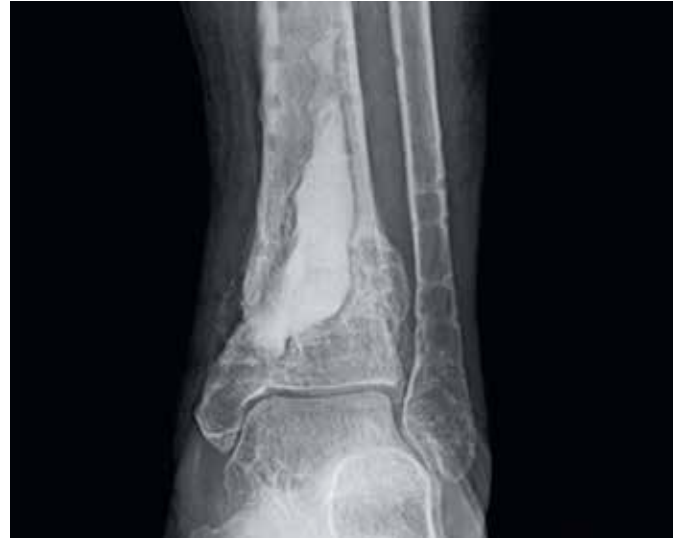
Osteomyelitis caused by group B *Streptococcus* and MRSA¹⁰

Patient presented with: drainage issues 1 year after pilon fracture repair and then 2 weeks after hardware removal.

Outcome: 6 months after treatment the patient was fully weight-bearing and without restrictions on activity – with complete absorption of STIMULAN.

73-year-old female with osteomyelitis caused by Group B *Streptococcus* and MRSA infection. Presented with exposed hardware and post-operative drainage issues, 1 year after pilon fracture repair and subsequently 2 weeks after removal of all hardware.

Hardware removal and repeat debridement on the medial side of the ankle resulted in a large dead space which was managed using **STIMULAN** paste. Antibiotics were administered to treat the infection.

6 months after treatment the patient was free from infection, fully weight bearing and without restrictions on activity – with complete absorption of **STIMULAN** paste.

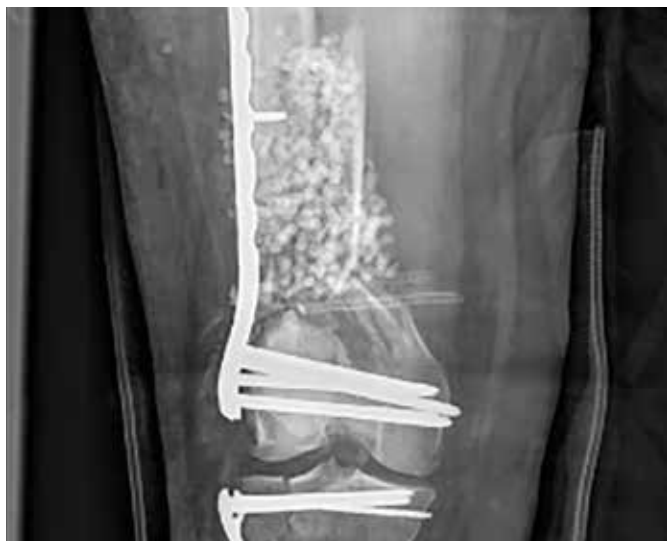
Bilateral high energy femoral fractures¹¹

Patient presented with: right open comminuted distal femoral fracture and tibial plateau fracture, and left closed comminuted femoral shaft fracture.

Outcome: complete absorption of **STIMULAN** and healing of the femoral defect after 4 months. At 1 year, patient was fully independently ambulatory with no pain.

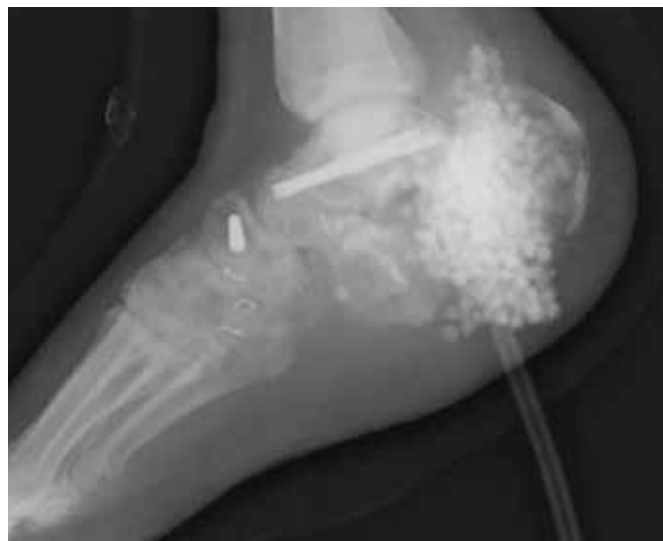
Open calcaneus fracture infected with MRSA¹⁰

Patient presented with: infected, MRSA positive non-union and hardware failure 6 months after treatment for an open calcaneus fracture.

Outcome: at 13 months the absorption of **STIMULAN** was complete, the patient was weight-bearing and without sign of infection – amputation was avoided.

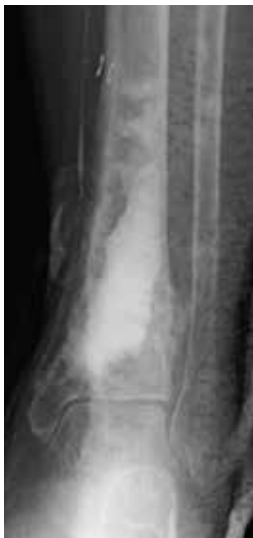
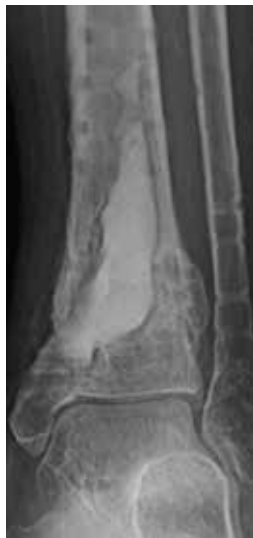
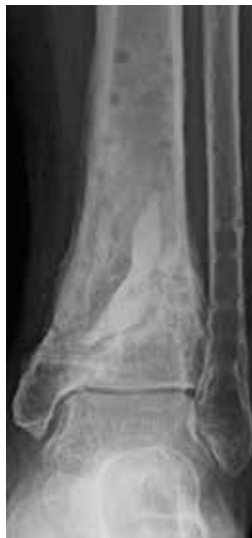
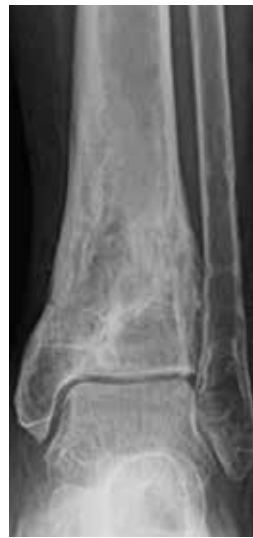
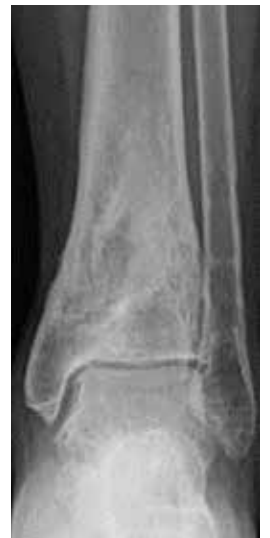
Truly absorbable and totally synthetic calcium sulfate — absorbs at an optimal rate⁸

Post-operative

1 month

11 weeks

6 months

15 months

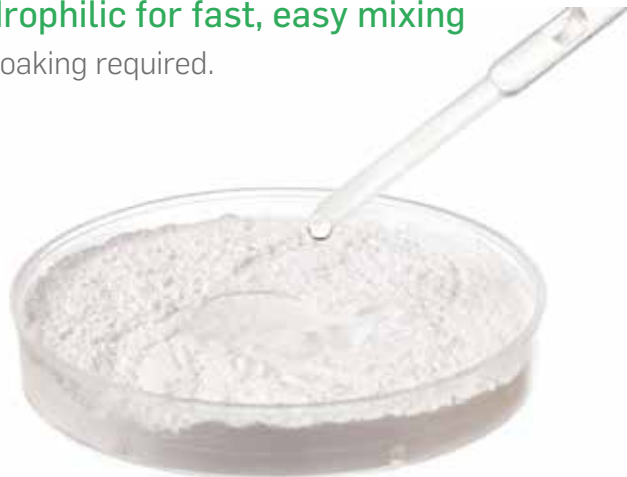
STIMULAN — mixes with liquid

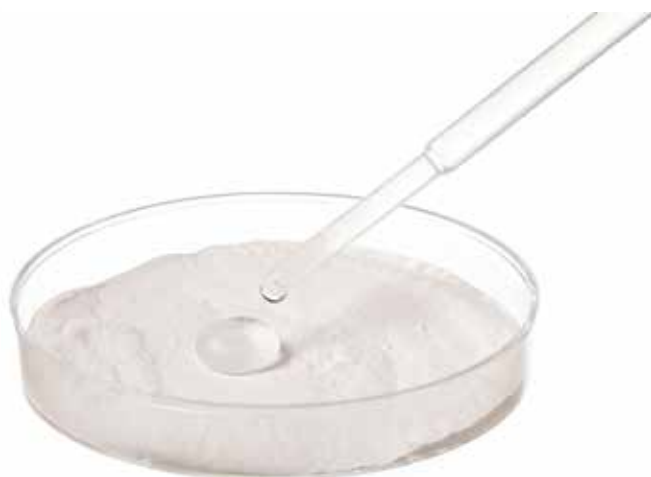
Competitor calcium sulfate — repels liquid

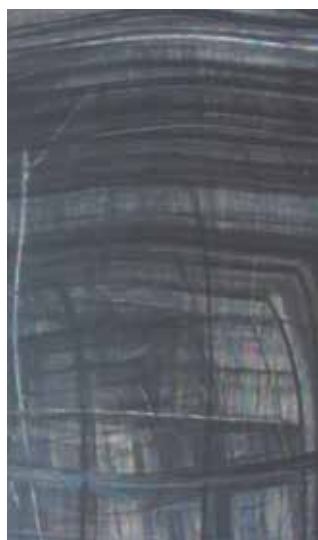
Microscope images (x6.5) of a cobalt chrome plate following damage simulation (360,000 cycles) with third body particles trapped between it and an articulating UHMWPE pin

STIMULAN does not damage total knee replacements when trapped between the articulating surfaces of the implant.

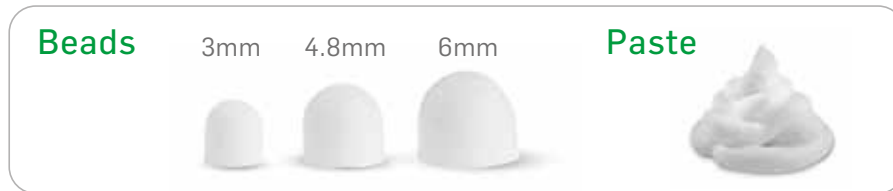
Bead mat available with **STIMULAN** Rapid Cure and **STIMULAN** Kit

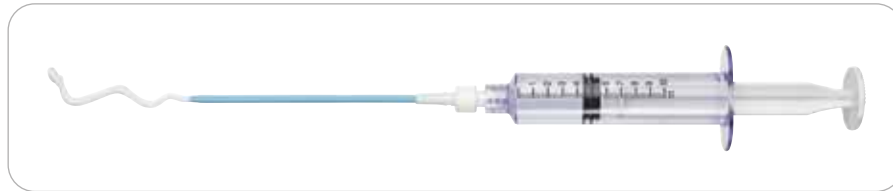
Syringe available with **STIMULAN** Kit

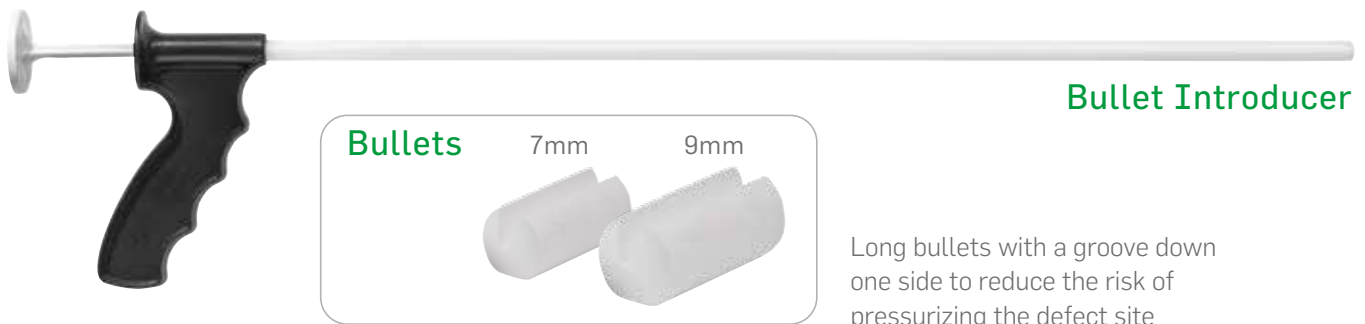
STIMULAN Bullet Mat and Introducer

Streamlined, flexible design that simplifies the delivery of **STIMULAN** for deep defects.

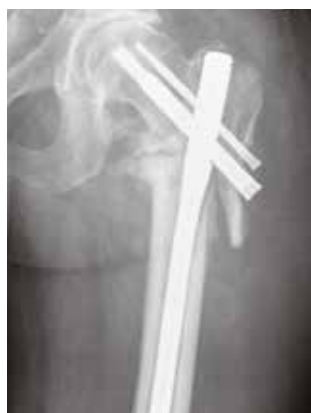
Pre-operative x-ray showing non-union

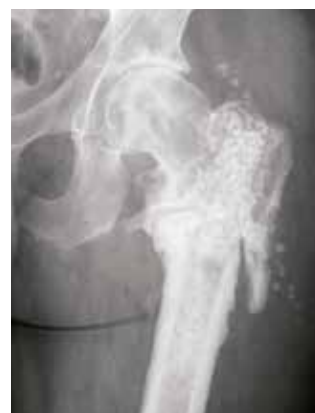
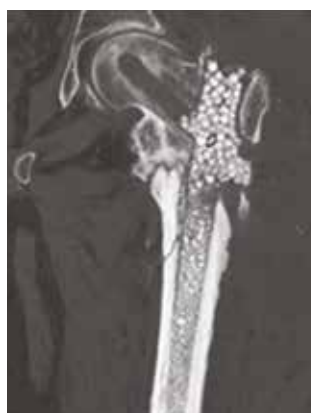
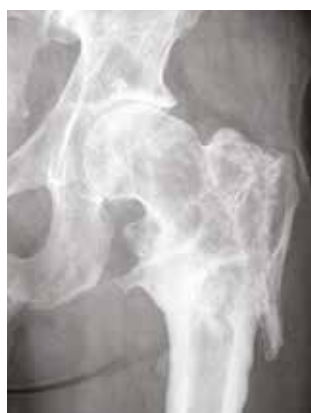
35-year-old male involved in a road traffic accident suffered multiple injuries and subtrochanteric fracture of left femur. This was nailed, but subsequently, he developed infection and drainage from both proximal and distal locking screw areas. He went to theatre multiple times and developed wound approx. 15cm on the proximal lateral thigh, which was treated with VAC.

X-ray – 2 months

CT – 2 months

1 year

Infected subtrochanteric fracture⁹

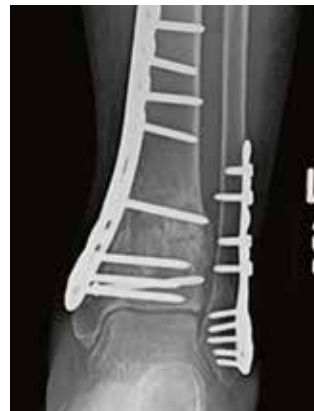
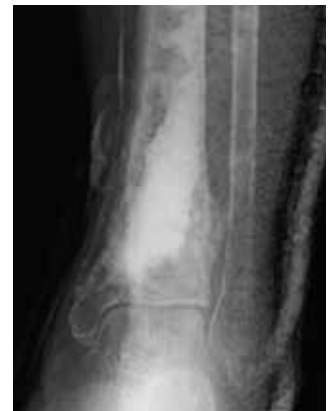
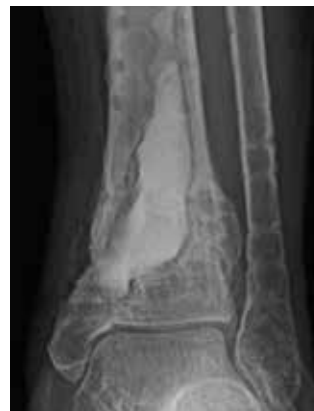
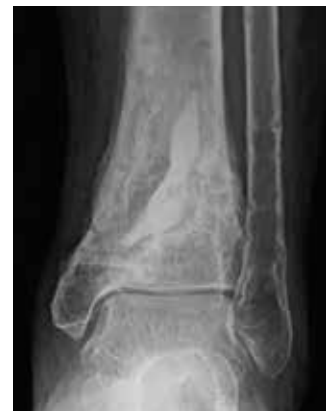
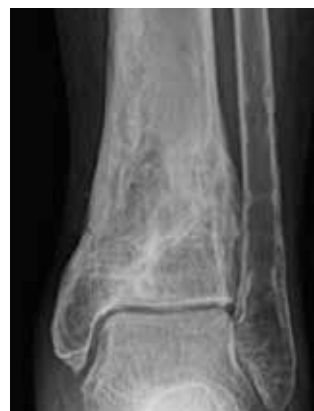
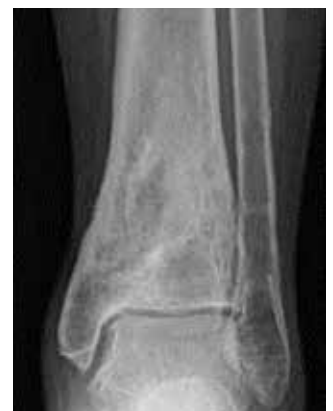
Presentation

Post-operative

1 month

11 weeks

6 months

15 months

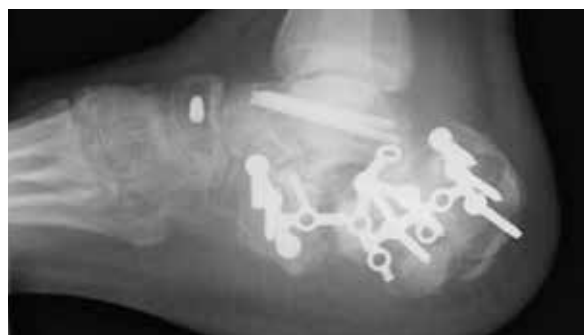
Presentation

40-year-old male sustained an open calcaneus fracture after a 20 foot fall. Initial surgery was an irrigation and debridement with definitive fixation 10 days after injury. 6 months later patient presented with an infected non-union and hardware failure. Cultures were positive for MRSA.

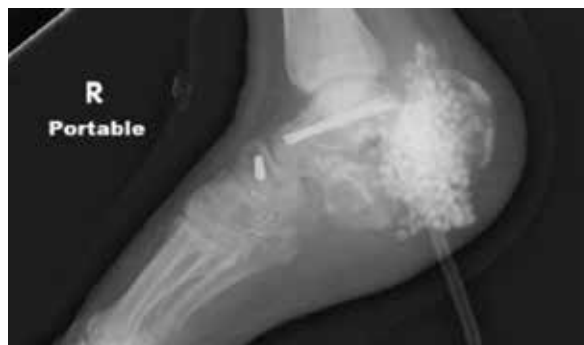
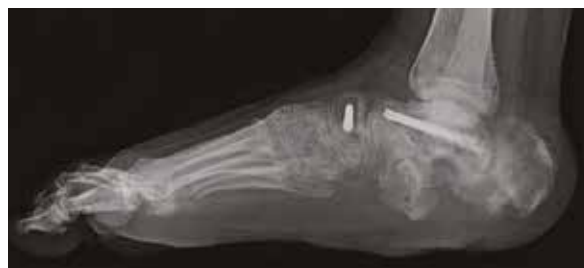
This patient is now weight bearing as tolerated and clinically no signs of infection. Infection in open calcaneus fractures is common and in some series amputation rates exceed 50%. For this patient a 2 stage approach was utilized to treat the infected non-union. Removal of hardware and aggressive debridement of the bone. The dead space was managed with **STIMULAN**.

Post-operative - Stage 1

Stage 1 complete

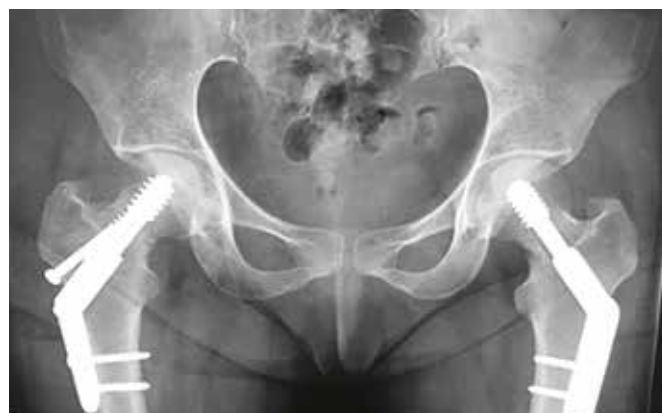
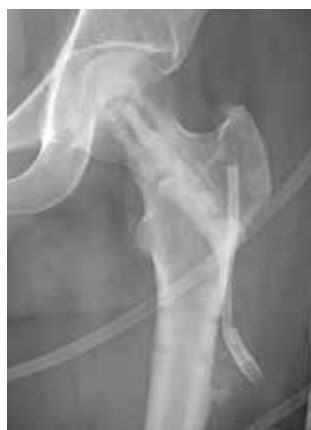
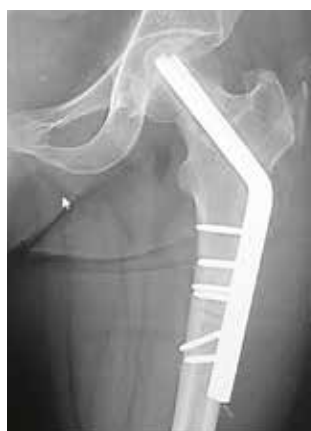
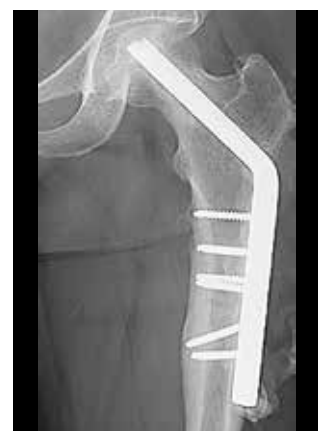
31-year-old female with metabolic bone disease who sustained a displaced right femoral neck fracture and a left femoral neck stress fracture after a low-energy fall. Initial surgery included ORIF with a sliding hip screw construct on the right side and placement of a prophylactic sliding hip screw on the left side to prevent fracture completion and displacement. She presented 6 months later with a left sided deep infection, non-union of her stress fracture and persistent pain.

6 weeks after stage 1 treatment, the patient was free from infection with complete absorption of **STIMULAN** paste. 4 months after stage 2 treatment, the non-union site appeared to be healed with no hardware failure and complete absorption of **STIMULAN**. Imaging at 1 year after stage 2 treatment confirmed consolidation at the non-union site and stable hardware.

Initial post-operative

Stage 1 – post-operative

Stage 2 – 4 months

Stage 2 – 2 years
